*Preserving Our Legacy*  
First Congregational Church

*Windows, Masonry, & Bricks*

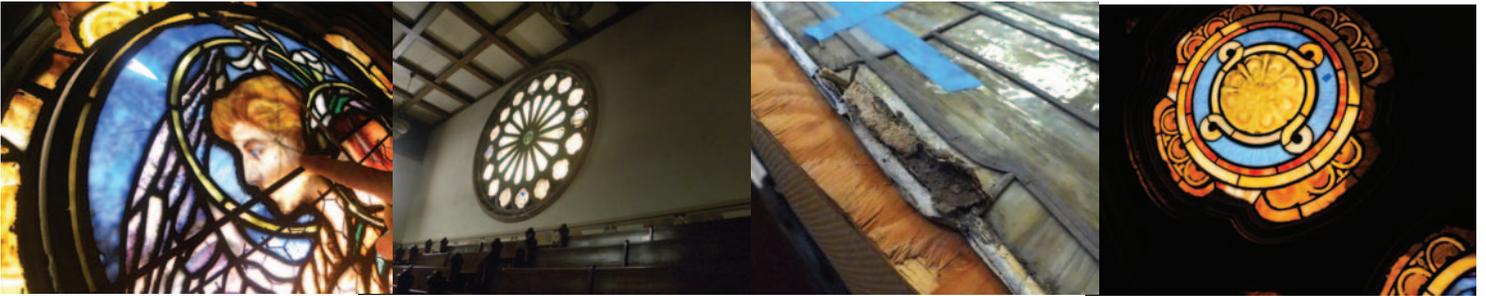
**Problem:** The stained glass windows were designed and created by Joseph Evan McKay in 1914. Currently they suffer from softened lead, ineffective caulking, cracks, chips and in some places BB gun holes.

**Repair:** The panes will be carefully removed from the frame and transported to J. Michael Design's studio where conservators will repaint areas of loss, re-fire pigments, replace broken and cracked glass, apply new leading and restore the wooden functional stops. The wood and plaster interior frames will be cleaned and restored onsite. Once completed the refreshed glass panes will return from the studio to be re-caulked into position.

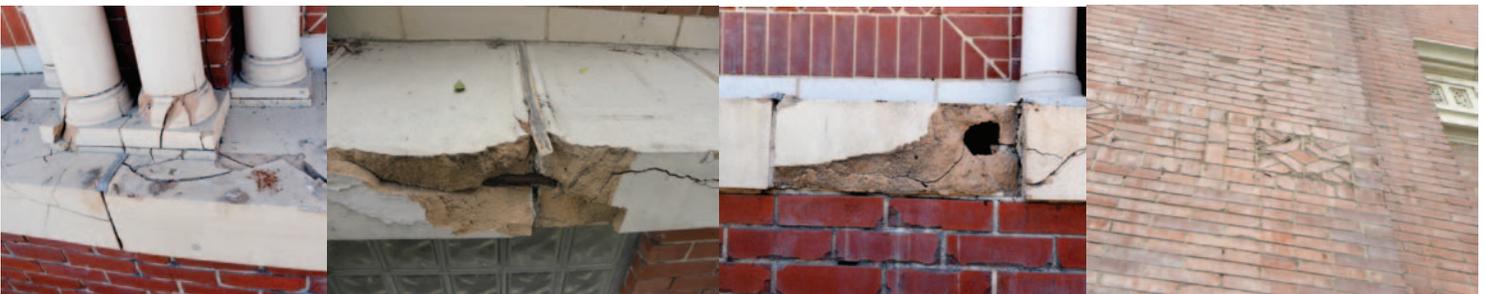
**Problems:** The terracotta elements on the east and north facades are cracked and chipped. Some of the hollow terracotta blocks that line Cedar and 3rd streets can no longer carry the load of the arches above. Many of the bricks have chipped or spalled--the brick face is gone, exposing soft internal material. The mortar has deteriorated in many places.

**Repairs:** The terra cotta cracks will be filled and missing elements will be remade and restored. Repairs will be cohesive with the original materials and will better withstand the elements. Several blocks will be removed and replaced with an alternative to match the original material providing more support for the terra cotta details above. Compromised bricks will be chipped out and replaced; salvageable bricks will be repaired in place. Old mortar will be scraped out and re-pointed or, where the mortar retains some structural integrity, a consolidant will be used to reinforce it.
